Release Note. (CP4 3.2.0)

Released CP4_3.2.0 version after testing CP4_3.2.0.RC9.

H/W : CP4, CP4S

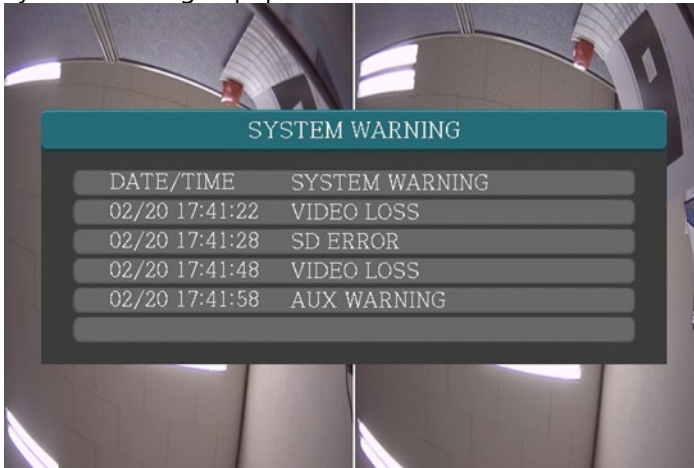
- Duration is initialized when another event is occurred within the duration.
- The list is initialized after the duration.
- vi. Pop-up window and warning list are initialized when pressing ESC button.
- vii. Pop-up window is not removed even the warning event is recovered.
- viii. Warning is displayed again when the event is occurred again from recovery.
- ix. System warning pop-up windows is only available on Live screen.
 - It is not available on Playback, Menu, another pop-up window on Live.
 - In the above condition, pop-up window is not displayed and event is not recorded, neither.
- x. System Warning Popup Windows

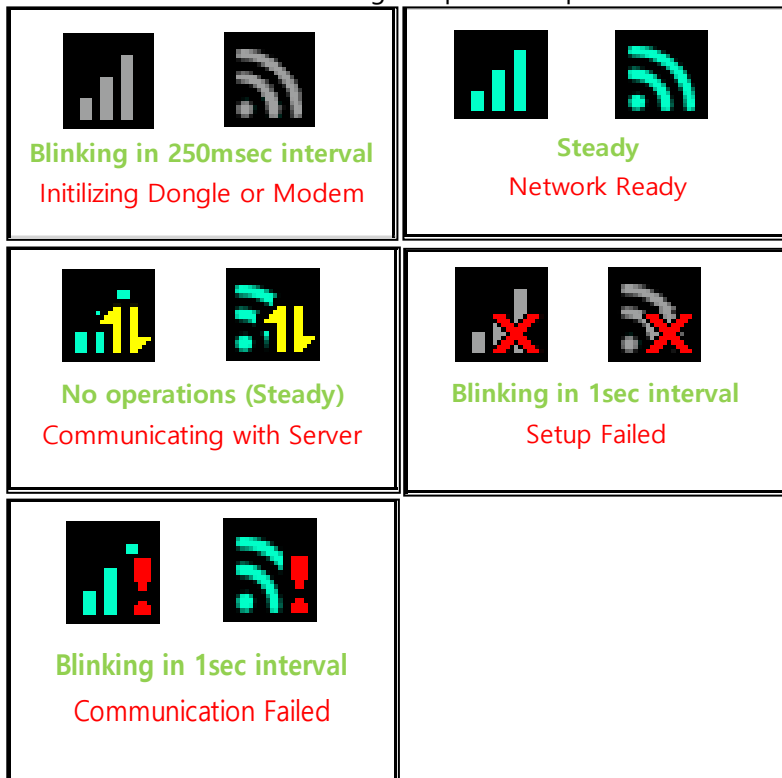
- 1) Network Status Icon and LED signal operation updated

Operating Status	ALARM LED	REC LED	NET LED
Power On	Steady	Steady	Steady
APPLICATION START	Steady	Blinking	OFF
SD Formatting	OFF	Fast Blinking	-
SYSTEM WARNING	Blinking	-	-
Record Error	Steady	OFF	-
SD FULL	Steady	OFF	-
No Record Setting	-	OFF	-
Event Recording	-	Fast Blinking	-
Recording but not triggering status	-	Steady	-
Initializing dongle or modem	-	-	Fast Blinking
Network Ready	-	-	Steady
Network in Progress	-	-	Steady
Device Setup Failure	-	-	Blinking
Network Failure with Server	-	-	Blinking
TaskOff	Steady	Steady	OFF
About to Shutdown	Steady	Steady	OFF
CPU OFF	OFF	OFF	OFF
